**Alpena Community College  
Alpena, Michigan**

**Five-Year Capital Outlay Plan  
2023-2027  
Submitted October 2021**

## Condition Reports

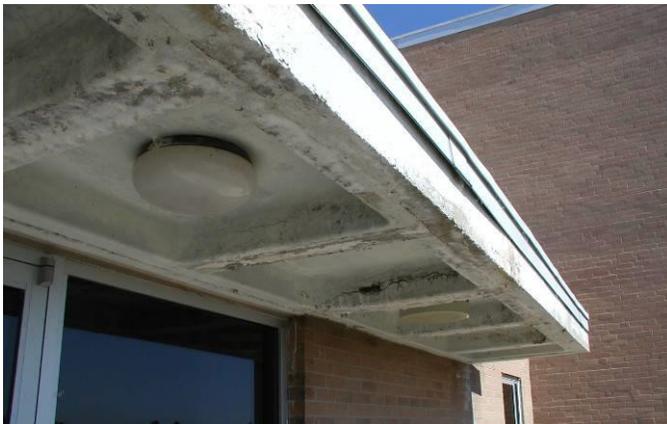
Concrete roof deterioration at the Natural Resources Center – reroofing may have stopped progression of problem.

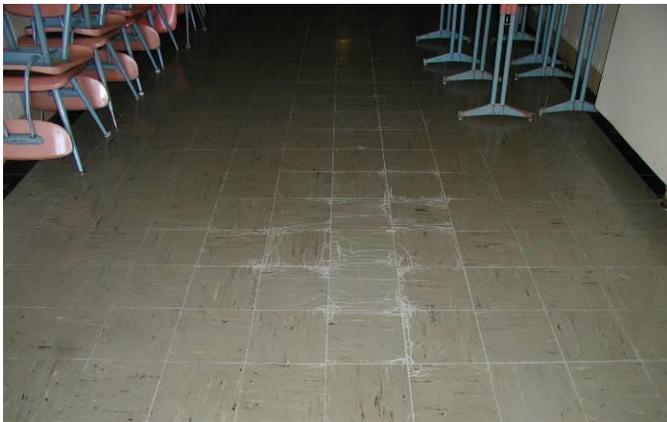
Original vinyl asbestos floor tile deterioration and adhesive failure at Van Lare Hall.

- Building reroofed in 2008. (EPDM roof was at end of life, leaking and due for replacement)
- Surging of water levels in boilers periodically causes shut down due to low water.
- Unit ventilators in classrooms older, near end of expected lifespan.
- Poor ventilation, poor air circulation in offices.
- Several distribution panels at or near capacity.
- New 2x4 fluorescent fixtures in suspended ceilings installed in corridors in 2008.
- New suspended 2x4 lay-in in corridors, offices, 102 and computer labs.
- Exterior original full-lite aluminum frame doors at end of life. Original hardware failing and due for replacement
- Corridor and entry flooring removed and replaced (2009).
- VAT flooring in classrooms. Tile breaking apart and coming loose as adhesive fails.

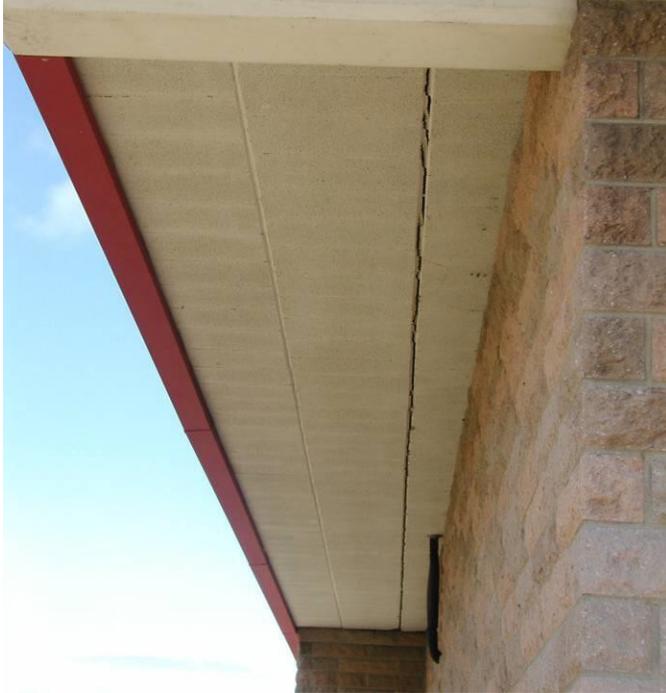
Concrete plank roof shifting at Besser Technology Center – connecting cables are suspect.

- Deck planks sagging, cracked – never tested to address structural integrity issue. Parts of deck falling at soffit. Bottom of block broken away
- Roofing: Durolast area showing continued signs of ponding. Some minor leaks at roof drains at built-up roof area.
- Window glazing compound brittle and cracked at windows, especially in 1972 addition, may require re-caulking/replacement
- Block wall sealant at exterior control joints at end of life., due for replacement
- Boilers replaced – summer 2008 with (3) high efficiency, pulse type boilers at a cost of \$103,000 for units and \$36,000 to remove existing and install new. Savings of \$30,000/year with improved efficiency gives a 4-1/2 year payback.)
- Horizontal unit vents functioning well but near end of life.

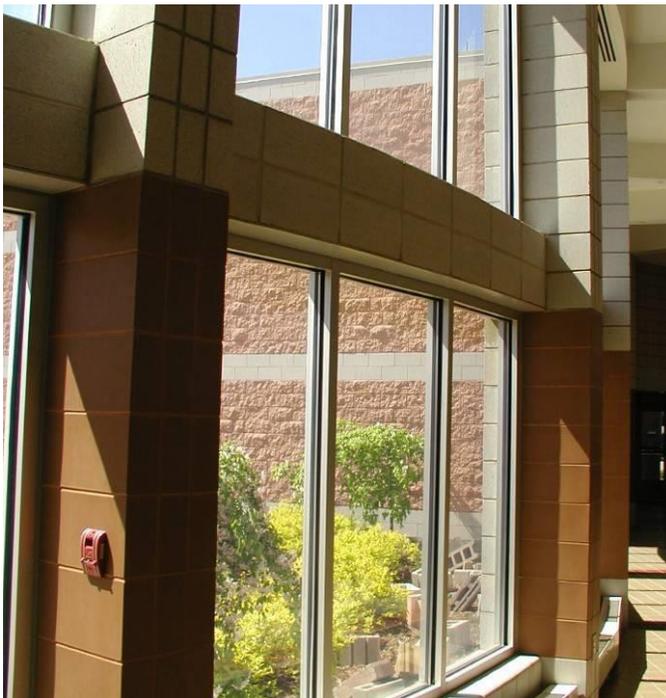
Concrete block between upper and lower windows allowing water infiltration – flashing is suspect.

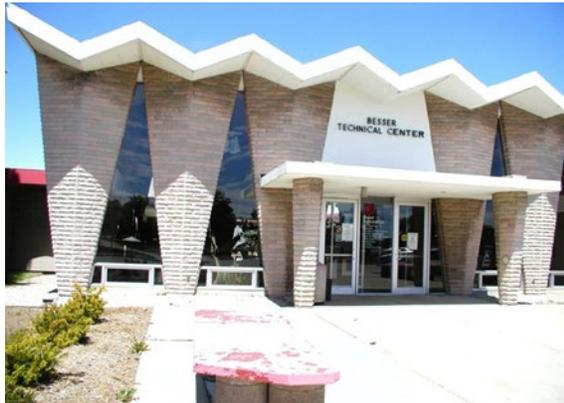
# Besser Technical Center

- HVAC Water pump bearing assembly failures becoming common with many replaced.
- Plumbing: Inadequate shut-off valves throughout building. Adding valves as repairs/modifications to the system are made.
- Power: Original underground 4160 V service, replaced in 2008 with 280/240v service.
- Casework: Science casework countertops in Physics lab at end of life, needs replacement or re-surfacing.
- Doors: (3) Machine shop and auto shop doors heavily rusted frames at end of life and due for replacement
- Floors: Some terrazzo deterioration at entries, due for re-grinding
- Site: Some cracking in concrete walks. Concrete at west entry heaved, chipped.
- Some washout at roof drain outlets

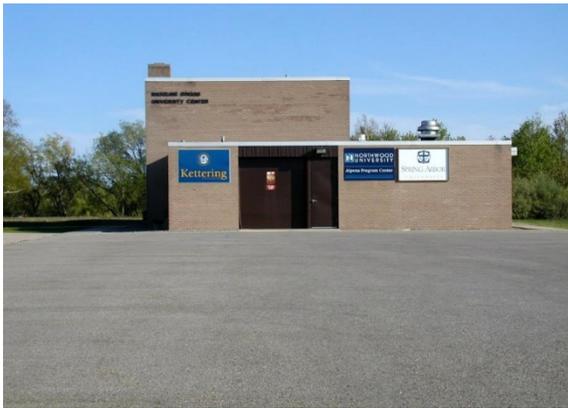
## University Center

- Durolast roof installed in 2008 (Built-up roof was at end of life, leaking and due for replacement)
- Extensive cracking in east block wall at garage
- Original single pane aluminum windows at end of life. Hopper windows with hardware in poor condition. Many units fastened shut.
- Heating controls poorly coordinated, temperature difficult to control
- Fire alarm original, not ADA compliant, not monitored.
- Exterior walks have settled at entry 3 +/-, trip hazard.

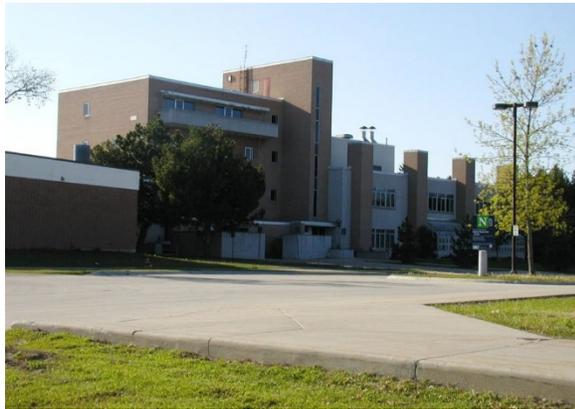
**Natural Resources Center**

- Settlement at first floor room 110, at building expansion joint. Floor and wall cracked and moved, appears to have stabilized. Engineer reports that no further movement anticipated.

- Windows at end of life – hardware failing, hinges sagging, gaskets on casements brittle. Windows leaking at stairwells.
- Hardware in poor condition. Window handle/ locking mechanism don't operate well – plastic parts wearing out and replacement part availability limited.

- Shut-off valves are inadequate and are added as repairs are made.
- Some distribution panels at or near capacity. No reported problems.
- Walls on level one and two repainted summer 2009.

- Spalling/ cracking of concrete waffle slab overhang and balcony floor at fourth floor boardroom, reinforcing exposed.

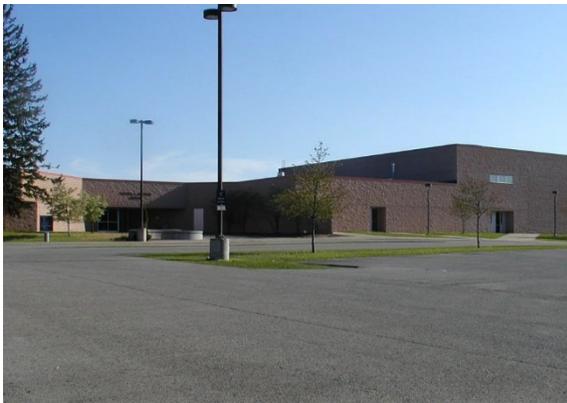
## Newport Center

- Fire suppression riser leaking at valve M168, likely packing failure
- Hollow metal service doors of auto body shops and arena rusting at bottom
- Carpet in wellness center entry shrinking and pulling at seams, potential trip hazard.

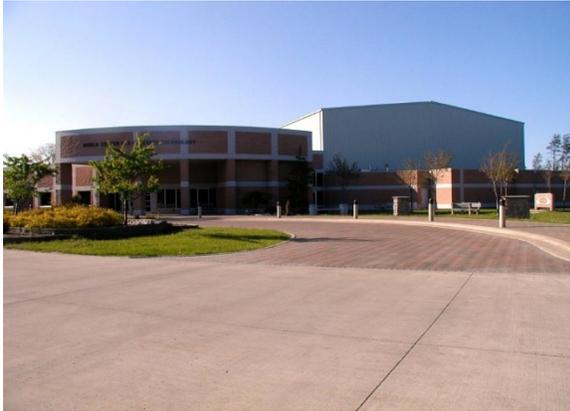
# World Center for Concrete Technology

- Water infiltration at main lobby, especially at main window wall, flashing may be inadequate and weeps may not be working.
- HVAC: Bearing assembly failures on Bell & Gossett pumps
- AHU #2 (heat only) for labs 105 & 107, unit is cutting out on power overload; cause is unknown
- Power: Voltage fluctuates – usually over. Investigating supply problem with Alpena Power
- Past frequent breaker tripping problem solved by redistributing loads on panels for certain areas
- Doors: Roll-up doors – NE plant door gearbox leaks oil, SE plant door has minor forklift damage. Manual overhead door between 107 & 109 damaged by forklift and will not close
- Heaving problems at concrete pavers in front drives repaired in 2006
- Salt deterioration on bollard light fixtures at front, most lights replaced

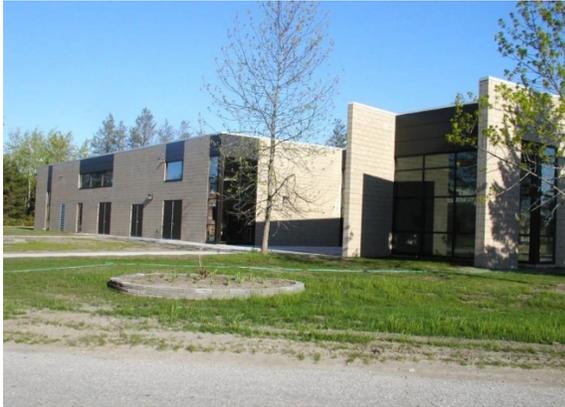
# Fine Arts Center

- Building new, under warranty
- Building HVAC creates negative pressure problems and concerns about proper distribution and ventilation throughout labs.
- Revolving darkroom door – not ADA accessible (only door).
