**Alpena Community College  
Alpena, Michigan**

**Five-Year Capital Outlay Plan  
2027-2031  
Submitted October 2025**

Alpena Community College's most recent Facility Condition Analysis report was prepared in 2024 by Integrated Design Inc. of Marquette, Michigan.

## Facility Condition Analysis

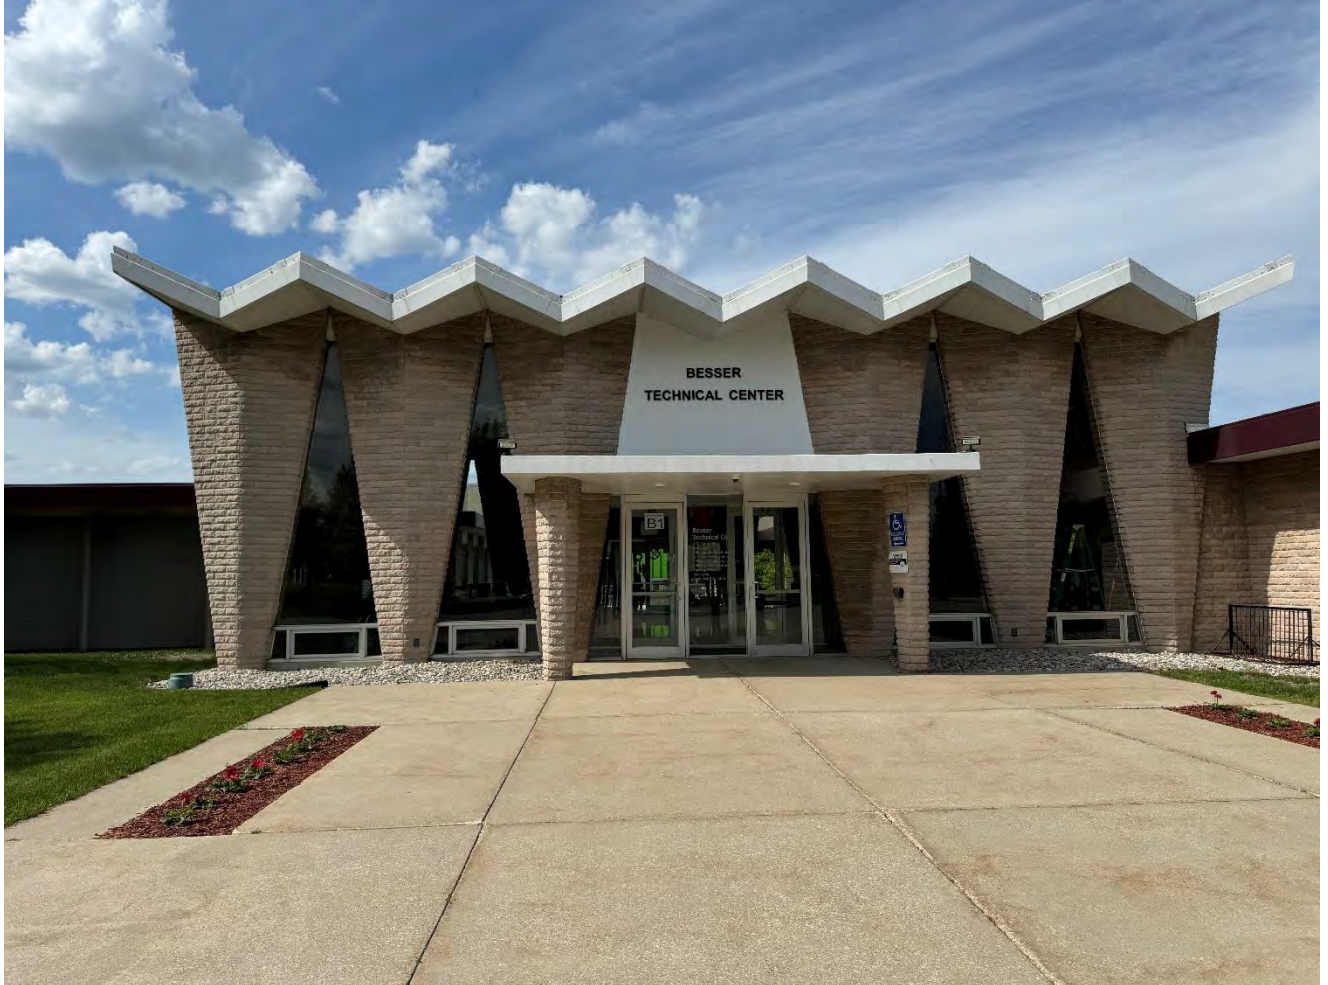
# Besser Technical Center

Besser Technical Center, built in 1962 with additions in 1996 and 2008, is primarily utilized as a general/vocational technology classroom building and overall is aging well. The structure of the building is mostly masonry construction including most of the roof structure. An area of concern is water infiltration through masonry in a few areas. Another area of concern is the building energy efficiency as the glazing is still mostly original single pane.

Many of the plumbing fixtures are original, still functional but the appearance is beginning to deteriorate. Two water cooler stations have bottle fillers and filtered water, while the remaining are older and do not. Roof drains are not properly spaced, nor is the roof properly sloped to drain off storm water. Storm water exits the roof through overflow scuppers and is causing damage to the Automotive area.

Existing lighting fixtures throughout the building are a variety of types and mix of LED and fluorescent tubes with approximately 50 percent of the building lighting fixtures retrofitted to LED tubes. Minimal emergency egress lighting exists, and most of the exit signs are original to the building's initial construction. A building wide replacement of the existing fixtures to LED with integral controls for daylight harvesting, dimming and occupancy sensing would result in energy savings and reduced maintenance costs.

The main power distribution panel of the building is in fair condition with limited spare capacity and should be replaced to allow for additional future loads. Select areas have been renovated and both lighting switches and receptacles have been replaced, however any the remaining devices that are original should be replaced. The existing fire alarm system panel is no longer supported by Simplex and should be replaced with a new code-compliant voice annunciation style system.

The pavements for the west drive, Lot B, and the east enclosed lot are aged and should be replaced. They are still in serviceable condition for their age, but potholes and pavement cracks are present. These have been treated to

maintain longevity. However, the potholes and alligator cracking indicate a weakening of the base material and any new pavement treatments will be less effective. There are some curbs in poor condition on the south side of Lot B and they should be replaced when Lot B is reconstructed. When considering reconstruction for Lot B, a parking count study is advisable. Reconfiguring the lot size to meet current needs may reduce the amount of reconstruction required.

The concrete loop drive, as well as the east drive off the loop, are in good condition. Some curbs around the loop are damaged, most likely from plowing. They are still serviceable, and replacement is not necessary.

Runoff from these parking lots is captured in a storm water system with the exception being the area in front of the loading dock on the west side of the facility. There is a catch basin in this location that's not connected to the existing system. The structure acts as an infiltration basin and the capacity, at times, is inadequate and ponding will occur.

- Some minor cracking in concrete sidewalks. Concrete at west entry heaved, chipped.
- Some washout at roof drain outlets.
- Asphalt pavements are serviceable but in need of replacement.
- Campus wayfinding signs are faded and aged. New signage should be considered throughout the campus.

- Block wall sealant at exterior control joints at end of life, due for replacement.
- "Dox" plank structural system sagging, cracked – never tested to address structural integrity issue. Vertical displacement observed at soffit. Spalling block in a few locations.

- 1996 built-up roof with membrane past useful life. Newer 2008 roofing close to end of life. Recommend replacing all roofing.
- Masonry above kitchen wall needs to be sealed as well as exterior wall at commons to prevent water from infiltrating through block.
- Original single pane storefront/windows past useful life and in need of replacement. Recommend replacing throughout building for energy savings. HM windows at Computer Commons are in need of replacement due to water infiltration at heads.
- Exterior doors are Aluminum single pane or HM in poor condition and/or rusting and in need of replacement. Recommend replacing throughout building for energy savings.
- Original interior doors have scratched finish/veneer damage. Recommend replacing all original doors.

- Original gang restrooms in need of updating.
  - Science classroom casework in poor condition. Recommend replacing.
- **Mechanical**
    - Many of the plumbing fixtures are original to the 162 building. While the function of the fixtures and flush valves appear to be working, appearances are deteriorating.

- The five older unfiltered water coolers and porcelain drinking fountains need to be replaced.
    - Several stormwater roof drain sumps are not insulated or poorly insulated, that can lead to condensation and dripping. Sumps and drains should be insulated.

- Unit ventilators in classrooms are original to the building, quite noisy and disturbing. Replace unit ventilators and add DX cooling coils (placed on roof if possible) so that rooms can be individually air conditioned.

- Cabinet heaters within the common corridors are original. Heaters appear to be functioning, but cabinet housing is in poor condition.
    - Provide ventilation for Offices 126A and 126B.

- **Electrical**
    - Existing Main Panel and branch circuit panels should be replaced. Panels are past their useful life expectancy and have limited space/spare capacity.

- Several of the original exit signs remain and should be replaced with LED source signs with built-in emergency battery back-up. Some areas also have missing exit signs.

- Existing fluorescent lighting and older/damaged fixtures should be replaced with LED fixtures with on-board controls for dimming, daylight harvesting and occupancy sensing.

- The original brown receptacle devices and light switches should be replaced with new to ensure proper and safe operation when used.
    - Existing data/communication wiring was observed to be functional and installed to serve workstations as needed. Wireless access points were observed and operational.

- Fire alarm original, not ADA complaint. Replace with new modern voice annunciation style system.

The stormwater system is original and installed over 50 years ago. The culverts between the catch basins should be scoped with a camera to note their condition and the basins should be cleaned out if needed. The infiltration basin should be connected into the stormwater system if possible.

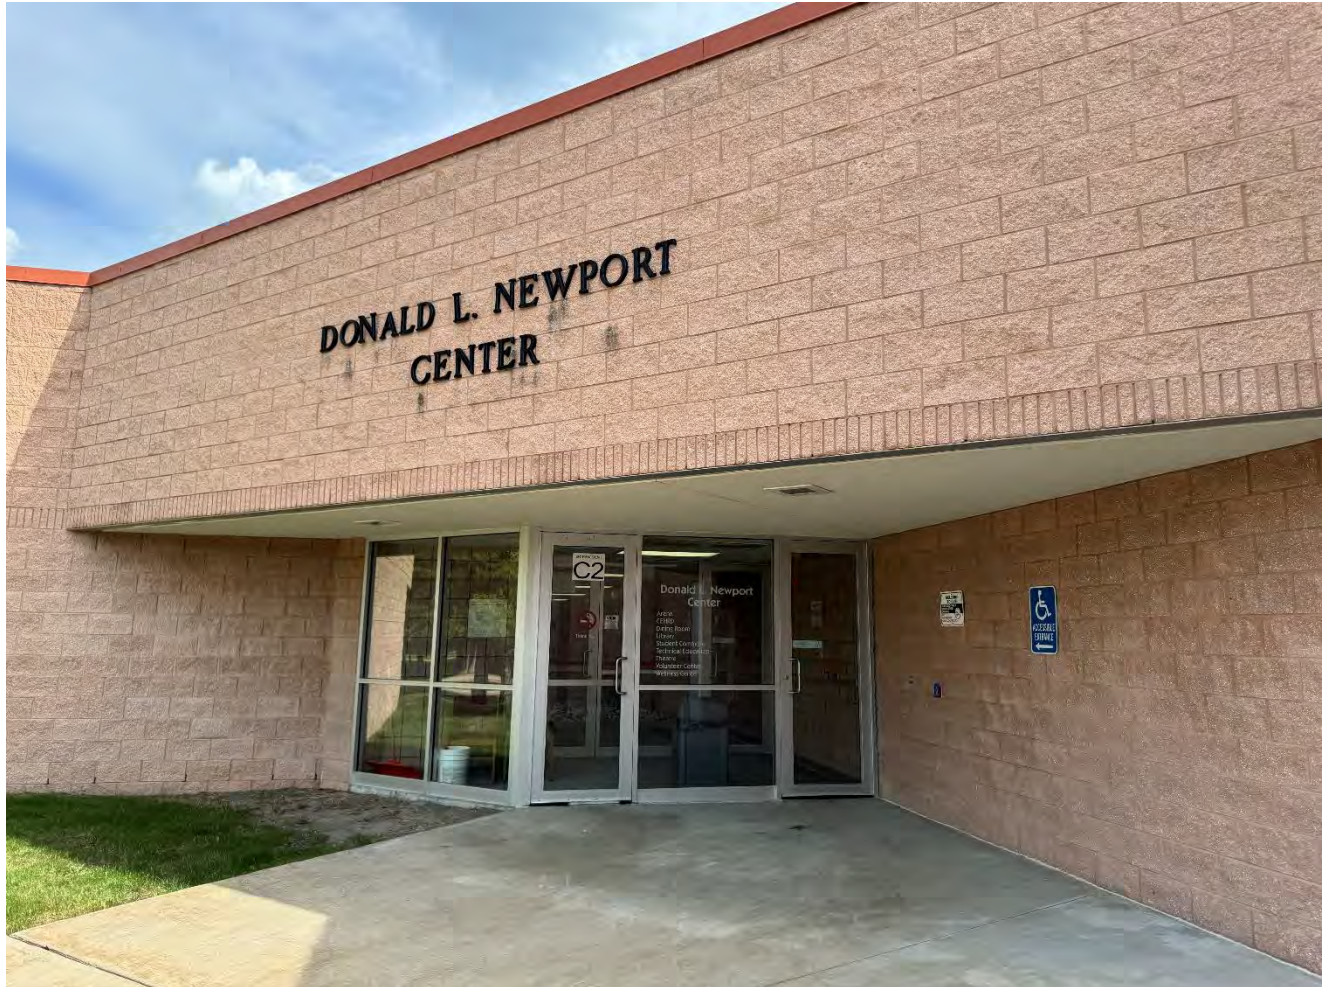
# Newport Center

Newport Center was built in 1996 with a remodel to machine shop in 2022. Exterior masonry construction is aging well. Mostly interior materials are original, and some are due for replacement including select doors, restroom sinks and partitions, and flooring.

Auditorium/Lecture Hall has a dedicated air handling unit with hot water heat and DX cooling coil. Park Arena has two large, packaged gas-fired heating, ventilating and cooling rooftop units. The locker rooms have a separate exhaust air handling unit with heat recovery coil and a pumped glycol loop to preheat outside air in AHU-2 serving the locker rooms. The Marine Technology Room and CAD Lab has a dedicated packaged rooftop unit, and the Reznor gas-fired heating-only rooftop unit serving the toilet rooms in the Marine Center is in need of replacement.

Building automation controls within the building are a mix of older pneumatic (replace), and new “Staefa Talon” controls that operate on the campus wide web platform.

Plumbing fixtures in the main building are in good condition. Toilet room fixtures in the Marine Technology toilet rooms are old and in need of replacement. The 500-MBH Lochinvar domestic water heater and large hot water storage tank in the mechanical room should be replaced, as well as the 199-MBH 100-gallon capacity 78% efficient water heater serving the kitchen.

A wet-pipe fire sprinkler system exists throughout the building and has a 30-hp fire pump that should be replaced.

Existing lighting fixtures throughout the building are a variety of types and mix of LED and fluorescent tubes with approximately 50 percent of the building lighting fixtures retrofitted to LED tubes. Minimal emergency egress lighting exists, and most of the exit signs are original to the building’s initial construction. A building wide replacement of the existing fixtures to LED with integral controls for daylight harvesting, dimming and occupancy sensing would result in energy savings and reduced maintenance costs.

The main power distribution panel of the building is in good condition with spare capacity and replacement parts readily available. Select areas have been renovated and both lighting switches and receptacles have been replaced, however any the remaining devices that are original should be replaced. The existing fire alarm system panel is no longer supported by Simplex and should be replaced with a new code-compliant voice annunciation style system.

Access to the Newport Center parking Lot C is from the drive on the west end of the campus and continues north past Lot B. The asphalt pavement is in serviceable condition for their age, but pavement cracks are present throughout and potholes are beginning to form. This indicates a weakening of the base material and deterioration of the pavement will accelerate. Crack sealing will slow the deterioration, however this treatment will need to be applied every 1-3 years and may ineffective on wider cracks.

- Concrete sidewalks are in good condition with some minor cracking.
- Asphalt pavement is serviceable but in need of replacement.
- Campus wayfinding signs are faded and aged. New signage should be considered throughout the campus.

- Pressure bar attachment at transition from low roof to arena wall has no counter-flashing; just caulk bead along top edge. Caulk is cracked, potentially allowing water on wall or from cavity to run inside building at transition bar location.
- Extensive patching dating to original installation, particularly at seams.
- Water infiltration at split faced, single width masonry walls.
- Control joints at gymnasium require tooling and caulk.
- Extensive concrete floor cracking at east machine shop require tooling and epoxy crack fill.

- Membrane roofing past its useful life and needs replacing as staff reports leaks at gym RTU.
- Glazing at Gym high windows needs replacing.
- Select exterior doors in poor condition including faded leafs and rusting frames at HM doors and corrosion at AL doors. Recommend removal and replacement with FRP doors and aluminum frame.
- Select original interior doors have scratched finish/veneer damage. Recommend replacing these doors.
- Original VCT floor tile throughout building with cracks at various areas should be replaced with LVP or LVT.
- Carpet at end of life in most areas of building.
- Original restrooms in fair condition. Recommend updating partitions, sinks and mirrors.

- Install filter on the water cooler outside of Lounge 118A.
- Upgrade the plumbing fixtures in the Marine Technology wing.
- Replace the 500-MBH domestic hot water boiler, storage tank, recirculation pump and piping with 199 MBH and 100-gallon capacity sealed combustion water heaters. Verify domestic water load before replacing with two and possibly combine kitchen hot water load with these heaters, eliminate the dedicated kitchen heater which is near the end of its useful life and install a dedicated 140 F hot water line to kitchen.

- Replace the Reznor make-up air unit and exhaust fan serving the Marine Tech toilet rooms with a new Energy Recovery Unit and reheat hot water coil in supply duct.

- Replace the air-cooled condensing unit located on grade north of the Marine Lab and East of the Lounge. New higher-pressure refrigerants will require that the ACCU, refrigerant piping and DX coil be replaced.

- There is no fresh air supplied to the toilet and locker rooms east of Park Arena. The rooms are significantly negative with respect to the corridor; so much so that the doors are held open and the air rushing past the door makes a loud wind noise. Recommend installing an ERV shared between these two restrooms.

- AHU-2 serving the locker rooms has an energy recovery water loop to capture energy from the exhaust air stream. When this AHU requires replacement, consider also eliminating the exhaust fan, glycol energy recovery loop, pump and hydronic specialties, and installing two energy recovery ventilators (one for each locker room) and duct reheat coils.

- Replace the Marine Tech/CADD Lab Rooftop Air Handling Unit.
- Properly distribute air and install zoned VAV boxes in Informational Office 108 where walls had been constructed to provide several enclosed offices in a previously large, open room.

- Service the rooftop unit RTU-6 on the Park Arena – believed to be not working due to relay failure; RTU-5 is handling the Arena load. The ventilation and heating load normally can be met with one of the two RTU's, with operation of units alternated via the BAS system. However, events with large crowd capacities likely require the use of both units to meet the ventilation load requirements. Add carbon dioxide space sensors in the arena and modify the control sequence for the RTU's to introduce only the ventilation air necessary to satisfy the occupant load.
