**Alpena Community College
Alpena, Michigan**

**Five-Year Capital Outlay Plan
2024-2028
Submitted October 2022**

Condition Reports

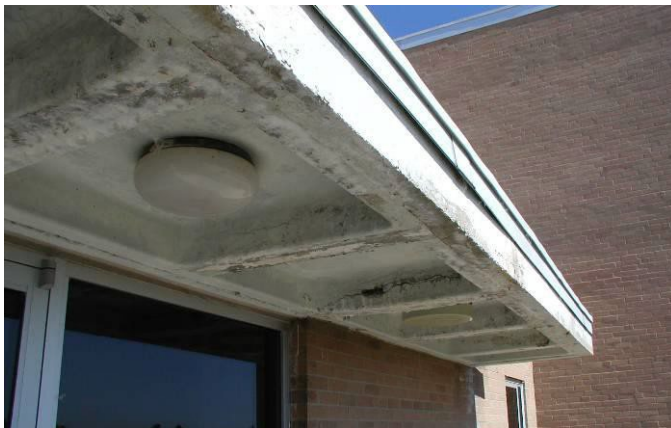
Concrete roof deterioration at the Natural Resources Center – reroofing may have stopped progression of problem.

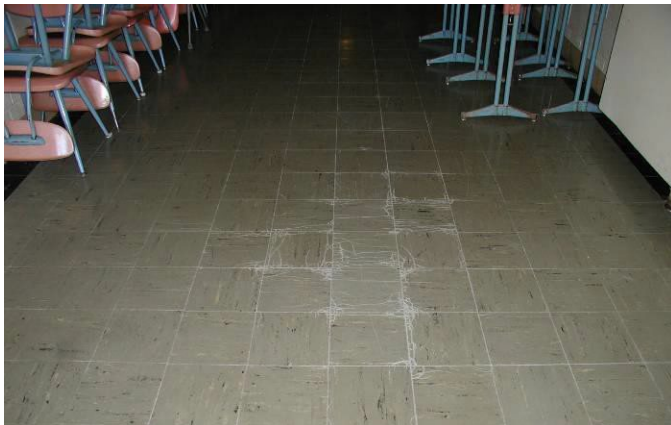
Original vinyl asbestos floor tile deterioration and adhesive failure at Van Lare Hall.

- Building reroofed in 2008. (EPDM roof was at end of life, leaking and due for replacement)
- Surging of water levels in boilers periodically causes shut down due to low water.
- Unit ventilators in classrooms older, near end of expected lifespan.
- Poor ventilation, poor air circulation in offices.
- Several distribution panels at or near capacity.
- New 2x4 fluorescent fixtures in suspended ceilings installed in corridors in 2008.
- New suspended 2x4 lay-in in corridors, offices, 102 and computer labs.
- Exterior original full-lite aluminum frame doors at end of life. Original hardware failing and due for replacement
- Corridor and entry flooring removed and replaced (2009).
- VAT flooring in classrooms. Tile breaking apart and coming loose as adhesive fails.
