**Alpena Community College  
Alpena, Michigan**

**Five-Year Capital Outlay Plan  
2025-2029  
Submitted October 2023**

#### **Condition Reports**

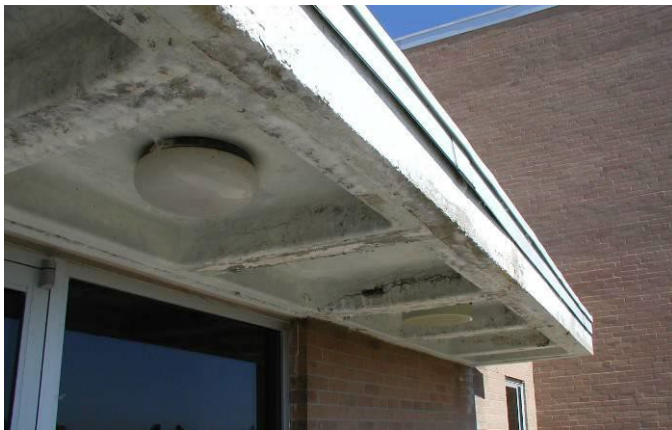
Concrete roof deterioration at the Natural Resources Center – reroofing may have stopped progression of problem.

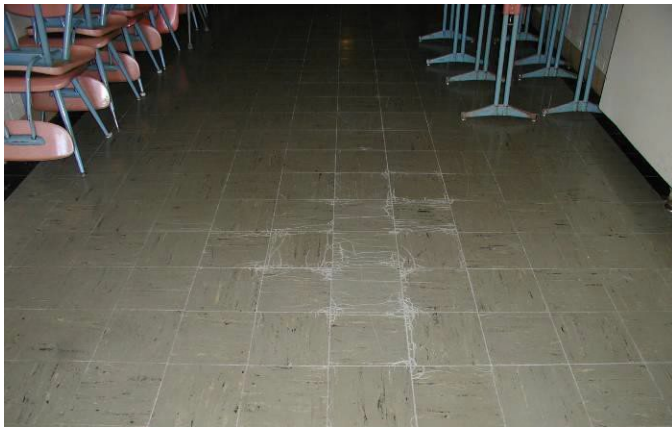
Original vinyl asbestos floor tile deterioration and adhesive failure at Van Lare Hall.

- Building reroofed in 2008. (EPDM roof was at end of life, leaking and due for replacement)
- Surging of water levels in boilers periodically causes shut down due to low water.
- Unit ventilators in classrooms older, near end of expected lifespan.
- Poor ventilation, poor air circulation in offices.
- Several distribution panels at or near capacity.
- New 2x4 fluorescent fixtures in suspended ceilings installed in corridors in 2008.
- New suspended 2x4 lay-in in corridors, offices, 102 and computer labs.
- Exterior original full-lite aluminum frame doors at end of life. Original hardware failing and due for replacement
- Corridor and entry flooring removed and replaced (2009).
- VAT flooring in classrooms. Tile breaking apart and coming loose as adhesive fails.

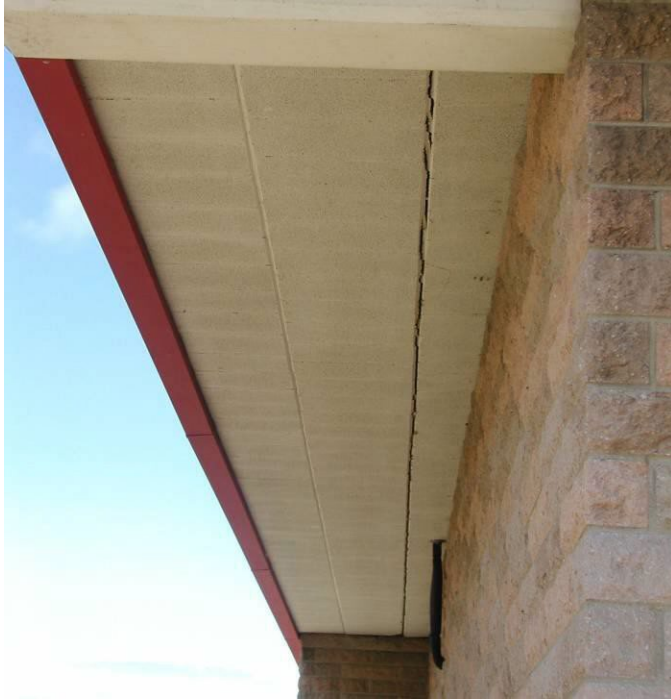
Concrete plank roof shifting at Besser Technology Center – connecting cables are suspect.

- Deck planks sagging, cracked – never tested to address structural integrity issue. Parts of deck falling at soffit. Bottom of block broken away
- Roofing: Durolast area showing continued signs of ponding. Some minor leaks at roof drains at built-up roof area.
- Window glazing compound brittle and cracked at windows, especially in 1972 addition, may require re-caulking/replacement
- Block wall sealant at exterior control joints at end of life., due for replacement
- Boilers replaced – summer 2008 with (3) high efficiency, pulse type boilers at a cost of \$103,000 for units and \$36,000 to remove existing and install new. Savings of \$30,000/year with improved efficiency gives a 4-1/2-year payback.)
- Horizontal unit vents functioning well but near end of life.

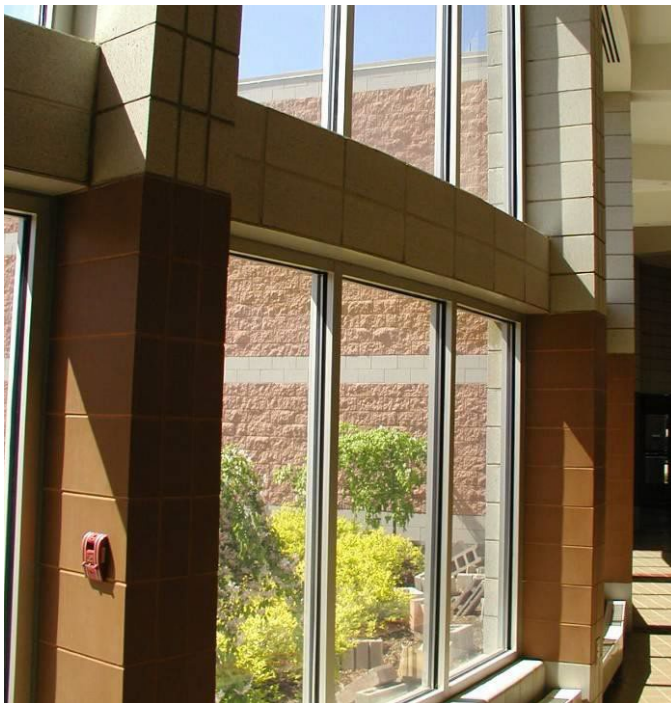
Concrete block between upper and lower windows allowing water infiltration – flashing is suspect.

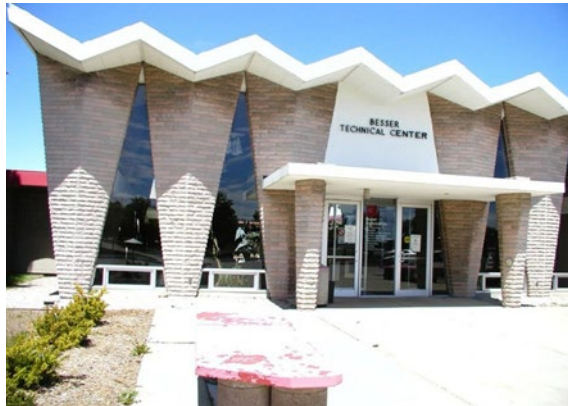
# Besser Technical Center

- HVAC Water pump bearing assembly failures becoming common with many replaced.
- Plumbing: Inadequate shut-off valves throughout building. Adding valves as repairs/modifications to the system are made.
- Power: Original underground 4160 V service, replaced in 2008 with 280/240v service.
- Casework: Science casework countertops in Physics lab at end of life, needs replacement or re-surfacing.
- Doors: (3) Machine shop and auto shop doors heavily rusted frames at end of life and due for replacement
- Floors: Some terrazzo deterioration at entries, due for re-grinding
- Site: Some cracking in concrete walks. Concrete at west entry heaved, chipped.
- Some washout at roof drain outlets

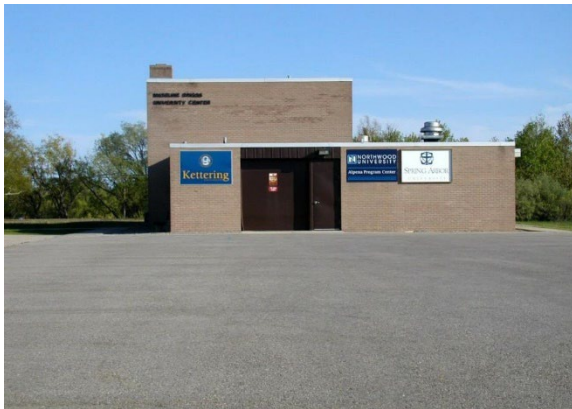
## University Center

- Durolast roof installed in 2008 (Built-up roof was at end of life, leaking and due for replacement)
- Extensive cracking in east block wall at garage
- Original single pane aluminum windows at end of life. Hopper windows with hardware in poor condition. Many units fastened shut.
- Heating controls poorly coordinated, temperature difficult to control
- Fire alarm original, not ADA compliant, not monitored.
- Exterior walks have settled at entry 3 +/-, trip hazard.

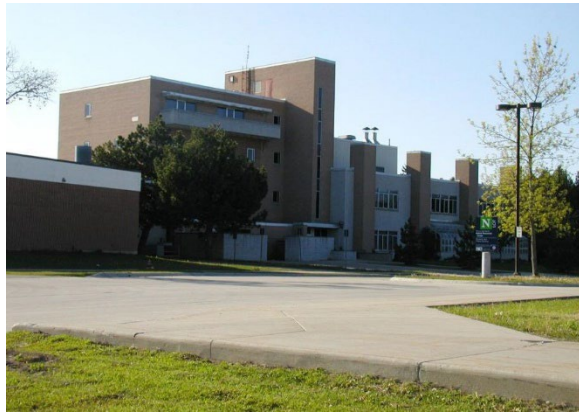
**Natural Resources Center**

- Settlement at first floor room 110, at building expansion joint. Floor and wall cracked and moved, appears to have stabilized. Engineer reports that no further movement anticipated.

- Windows at end of life – hardware failing, hinges sagging, gaskets on casements brittle. Windows leaking at stairwells.
- Hardware in poor condition. Window handle/ locking mechanism don't operate well – plastic parts wearing out and replacement part availability limited.

- West entry curtain wall - caulk deteriorating, aluminum frames pitted, system at end of life, due for replacement
- (5) Chemistry and Biology fume hoods replaced as part of 2006 renovations. Fume hoods not on constantly – corrosives cabinet vents into system, but not on unless fume hood is on. Verify with safety regulator to determine system operation requirements.

- No shut-off valves for HVAC system make maintenance very difficult.
- Valves added when possible as repairs are made.
- Pumps had high failure rate on bearing assemblies, replaced with new type that has resolved the problem.

- Shut-off valves are inadequate and are added as repairs are made.
- Some distribution panels at or near capacity. No reported problems.
- Walls on level one and two repainted summer 2009.

- Spalling/ cracking of concrete waffle slab overhang and balcony floor at fourth floor boardroom, reinforcing exposed.

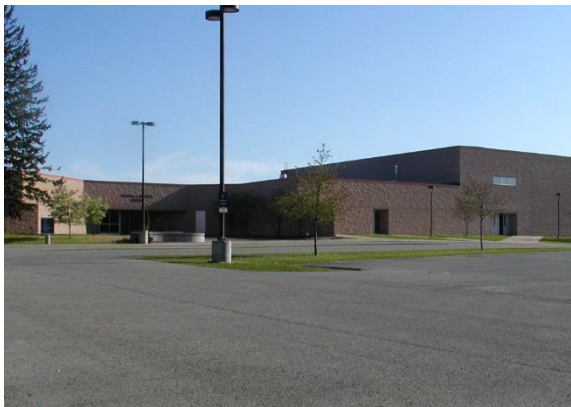
## Newport Center

- Fire suppression riser leaking at valve M168, likely packing failure
- Hollow metal service doors of auto body shops and arena rusting at bottom
- Carpet in wellness center entry shrinking and pulling at seams, potential trip hazard.

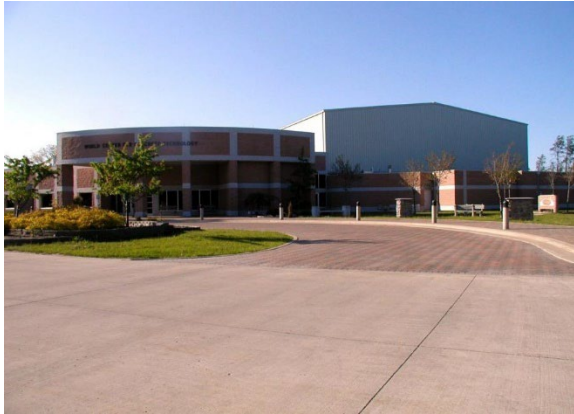
# World Center for Concrete Technology

- Water infiltration at main lobby, especially at main window wall, flashing may be inadequate and weeps may not be working.
- HVAC: Bearing assembly failures on Bell & Gossett pumps
- AHU #2 (heat only) for labs 105 & 107, unit is cutting out on power overload; cause is unknown
- Power: Voltage fluctuates – usually over. Investigating supply problem with Alpena Power
- Past frequent breaker tripping problem solved by redistributing loads on panels for certain areas
- Doors: Roll-up doors – NE plant door gearbox leaks oil, SE plant door has minor forklift damage. Manual overhead door between 107 & 109 damaged by forklift and will not close
- Heaving problems at concrete pavers in front drives repaired in 2006
- Salt deterioration on bollard light fixtures at front, most lights replaced

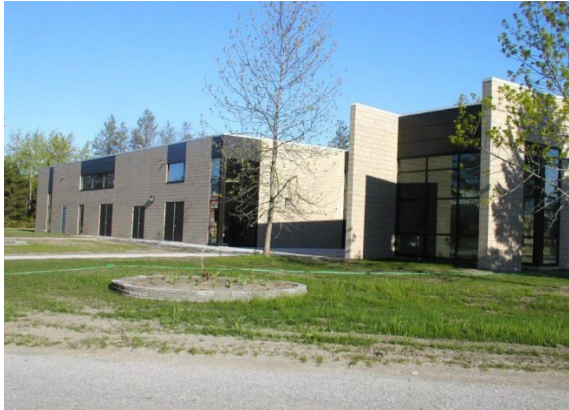
# Fine Arts Center

- Building new, under warranty
- Building HVAC creates negative pressure problems and concerns about proper distribution and ventilation throughout labs.
- Revolving darkroom door – not ADA accessible (only door).
