**Alpena Community College
Alpena, Michigan**

**Five-Year Capital Outlay Plan
FY2022-2026
Submitted October 2020**

Condition Reports

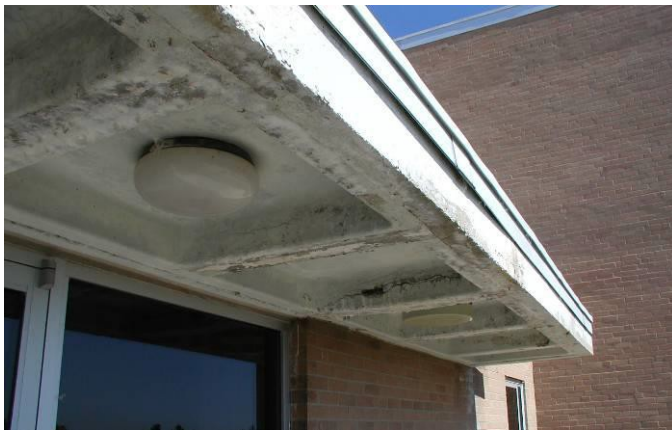
Concrete roof deterioration at the Natural Resources Center – reroofing may have stopped progression of problem.

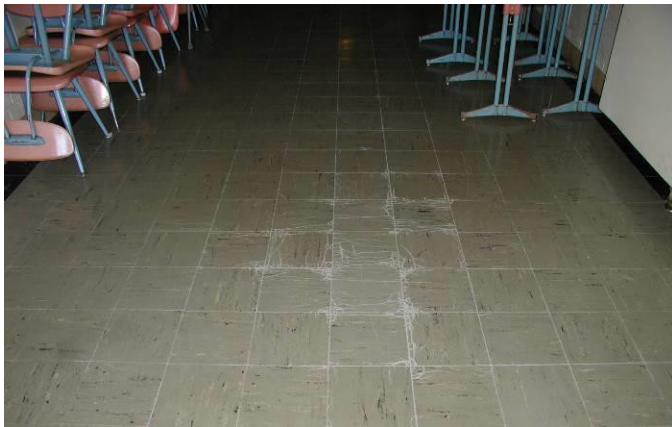
Original vinyl asbestos floor tile deterioration and adhesive failure at Van Lare Hall.

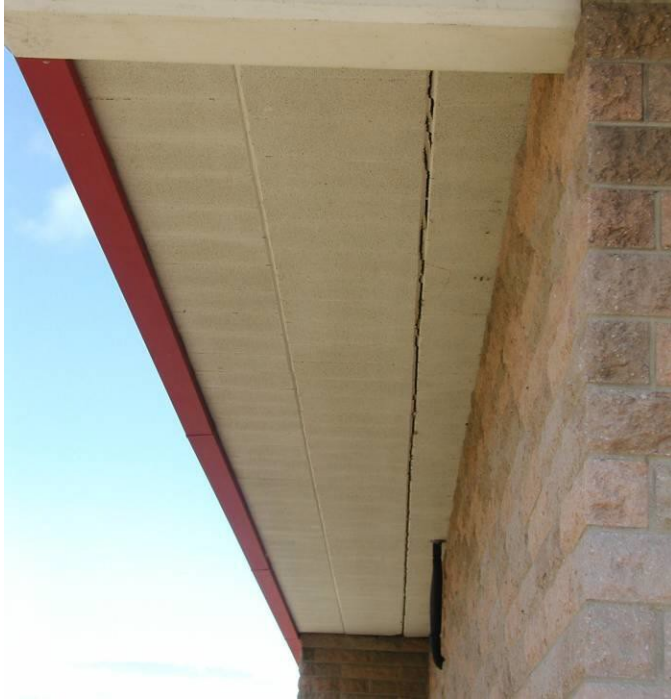
Concrete plank roof shifting at Besser Technology Center – connecting cables are suspect.

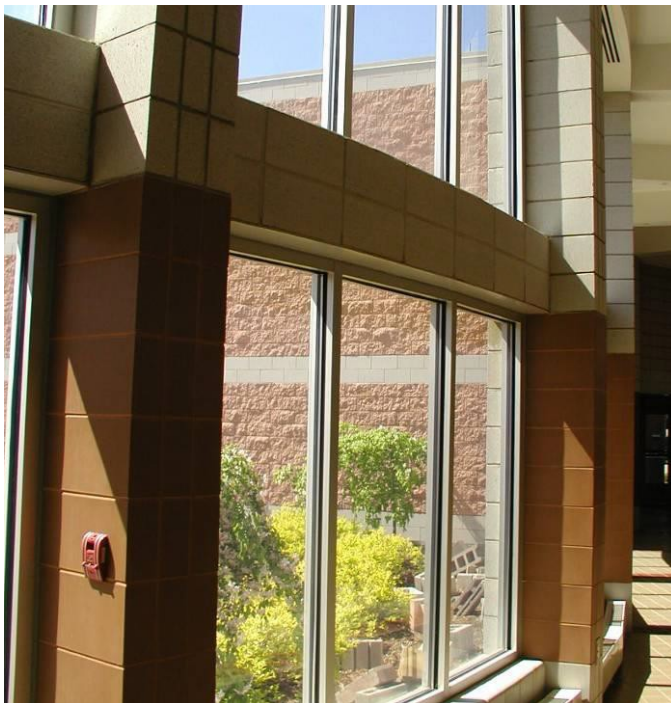
Concrete block between upper and lower windows allowing water infiltration – flashing is suspect.

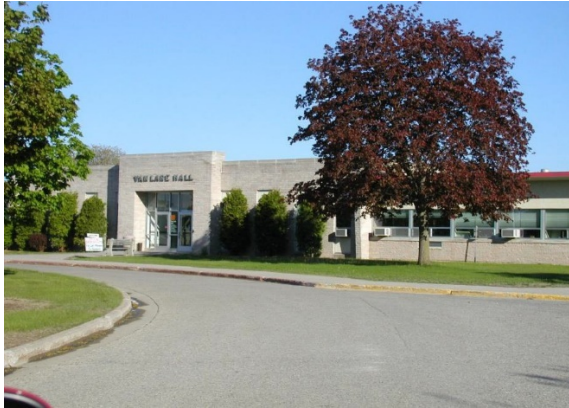
Van Lare Hall

- Building reroofed in 2008. (EPDM roof was at end of life, leaking and due for replacement)
- Surging of water levels in boilers periodically causes shut down due to low water.
- Unit ventilators in classrooms older, near end of expected lifespan.
- Poor ventilation, poor air circulation in offices.
- Several distribution panels at or near capacity.
- New 2x4 fluorescent fixtures in suspended ceilings installed in corridors in 2008.
- New suspended 2x4 lay-in in corridors, offices, 102 and computer labs.
- Exterior original full-lite aluminum frame doors at end of life. Original hardware failing and due for replacement
- Corridor and entry flooring removed and replaced (2009).
- VAT flooring in classrooms. Tile breaking apart and coming loose as adhesive fails.

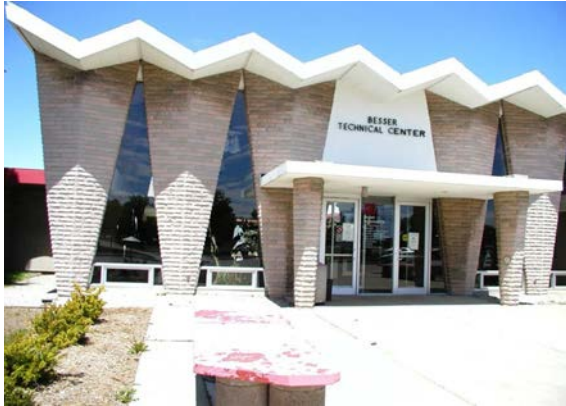
Besser Technical Center

- Deck planks sagging, cracked – never tested to address structural integrity issue. Parts of deck falling at soffit. Bottom of block broken away
- Roofing: Durolast area showing continued signs of ponding. Some minor leaks at roof drains at built-up roof area.
- Window glazing compound brittle and cracked at windows, especially in 1972 addition, may require re-caulking/replacement
- Block wall sealant at exterior control joints at end of life., due for replacement
- Boilers replaced – summer 2008 with (3) high efficiency, pulse type boilers at a cost of \$103,000 for units and \$36,000 to remove existing and install new. Savings of \$30,000/year with improved efficiency gives a 4-1/2 year payback.)
- Horizontal unit vents functioning well but near end of life.

- HVAC Water pump bearing assembly failures becoming common with many replaced.
- Plumbing: Inadequate shut-off valves throughout building. Adding valves as repairs/modifications to the system are made.
- Power: Original underground 4160 V service, replaced in 2008 with 280/240v service.
- Casework: Science casework countertops in Physics lab at end of life, needs replacement or re-surfacing.
- Doors: (3) Machine shop and auto shop doors heavily rusted frames at end of life and due for replacement
- Floors: Some terrazzo deterioration at entries, due for re-grinding
- Site: Some cracking in concrete walks. Concrete at west entry heaved, chipped.
- Some washout at roof drain outlets

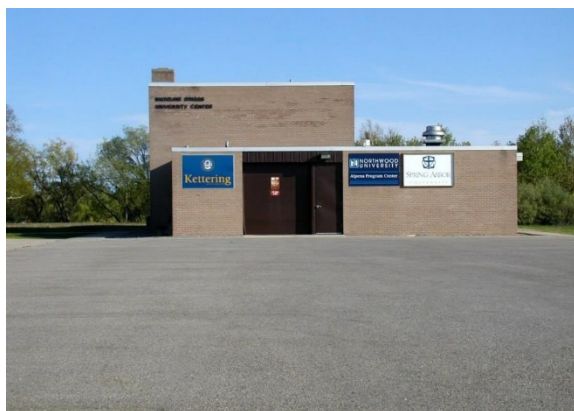
University Center

- Durolast roof installed in 2008 (Built-up roof was at end of life, leaking and due for replacement)
- Extensive cracking in east block wall at garage
- Original single pane aluminum windows at end of life. Hopper windows with hardware in poor condition. Many units fastened shut.
- Heating controls poorly coordinated, temperature difficult to control
- Fire alarm original, not ADA compliant, not monitored.
- Exterior walks have settled at entry 3 +/-, trip hazard.

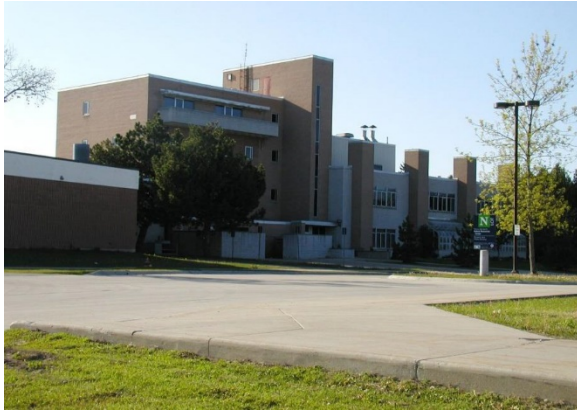
Natural Resources Center

- Settlement at first floor room 110, at building expansion joint. Floor and wall cracked and moved, appears to have stabilized. Engineer reports that no further movement anticipated.

- Windows at end of life – hardware failing, hinges sagging, gaskets on casements brittle. Windows leaking at stairwells.
- Hardware in poor condition. Window handle/ locking mechanism don't operate well – plastic parts wearing out and replacement part availability limited.

- West entry curtain wall - caulk deteriorating, aluminum frames pitted, system at end of life, due for replacement
- (5) Chemistry and Biology fume hoods replaced as part of 2006 renovations. Fume hoods not on constantly – corrosives cabinet vents into system, but not on unless fume hood is on. Verify with safety regulator to determine system operation requirements.

- No shut-off valves for HVAC system make maintenance very difficult.
- Valves added when possible as repairs are made.
- Pumps had high failure rate on bearing assemblies, replaced with new type that has resolved the problem.

- Shut-off valves are inadequate and are added as repairs are made.
- Some distribution panels at or near capacity. No reported problems.
- Walls on level one and two repainted summer 2009.

- Spalling/ cracking of concrete waffle slab overhang and balcony floor at fourth floor boardroom, reinforcing exposed.

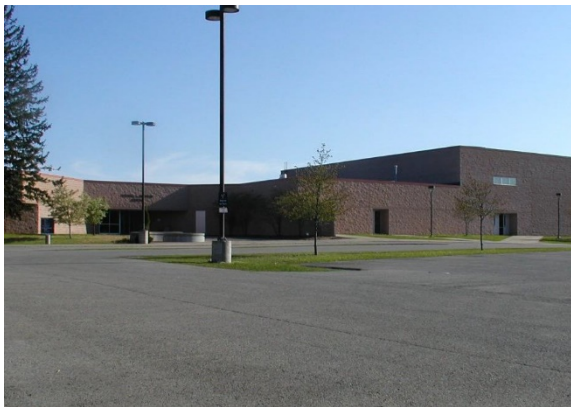
Newport Center

- Settlement at classroom 111. Some initial settlement, no further movement since.
- Water infiltration at split faced, single width masonry walls
- Pressure bar attachment at transition from low roof to arena wall has no counter-flashing; just caulk bead along top edge. Caulk is cracked, potentially allowing water on wall or from cavity to run inside building at transition bar location.

- Extensive patching dating to original installation, particularly at seams.
- Patch adhesive showing signs of failure. Monitor condition and repair as necessary to prevent further deterioration.

- Glazing gasket on interior of windows popping out – pushed back in place on a regular basis.
- AHU #6 at the arena is not working due to relay failure, AHU #5 is handling the load alone

- Fire suppression riser leaking at valve M168, likely packing failure
- Hollow metal service doors of auto body shops and arena rusting at bottom
- Carpet in wellness center entry shrinking and pulling at seams, potential trip hazard.

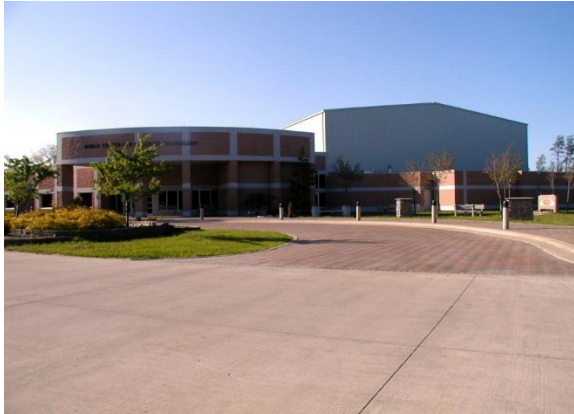
World Center for Concrete Technology

- Water infiltration at main lobby, especially at main window wall, flashing may be inadequate and weeps may not be working.
- HVAC: Bearing assembly failures on Bell & Gossett pumps
- AHU #2 (heat only) for labs 105 & 107, unit is cutting out on power overload; cause is unknown
- Power: Voltage fluctuates – usually over. Investigating supply problem with Alpena Power
- Past frequent breaker tripping problem solved by redistributing loads on panels for certain areas
- Doors: Roll-up doors – NE plant door gearbox leaks oil, SE plant door has minor forklift damage. Manual overhead door between 107 & 109 damaged by forklift and will not close
- Heaving problems at concrete pavers in front drives repaired in 2006
- Salt deterioration on bollard light fixtures at front, most lights replaced

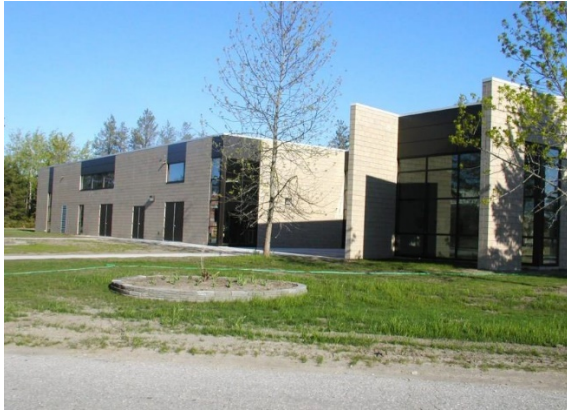
Fine Arts Center

- Building new, under warranty
- Building HVAC creates negative pressure problems and concerns about proper distribution and ventilation throughout labs.
- Revolving darkroom door – not ADA accessible (only door).

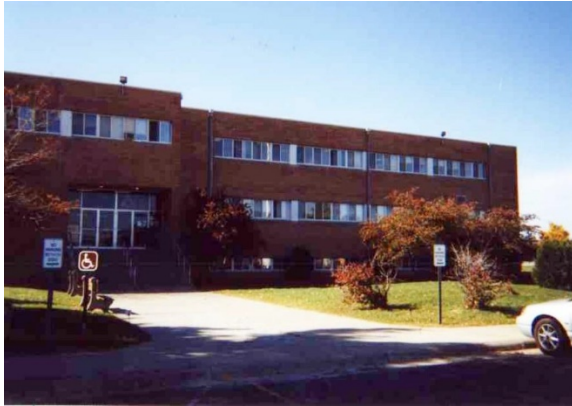
Oscoda Campus

- Roof: Some roof leaks at edges of NE & NW corners. Downspout at boiler room door loose, pulling off building
- Windows: Original insulated glazed, sliding aluminum windows in good condition. Hardware in good condition, locks work well.
- Cladding: Evidence of brick damage and replacement at new stair/ elevator tower in SW corner. Brick still appears to be problematic in these areas.
- HVAC: Most components are original, near or past end of life. Above-ceiling AHU's are very noisy; several only operate when lights are on - very poor air quality. (2) intake louvers at lower level are covered, should be uncovered for better indoor air quality.
- Excessive humidity problems evident from sagging ceiling tile.
- Server closet on second floor overheats.

- Ceilings: Sagging tiles on all floors, especially the 1st floor. Grid is stained and rusty, due for re-paint. Grid damaged in computer lab. 5+% of ceiling tile is stained or damaged by water.
