**Alpena Community College
Alpena, Michigan**

**Five-Year Capital Outlay Plan
2024-2028
Submitted October 2022**

Condition Reports

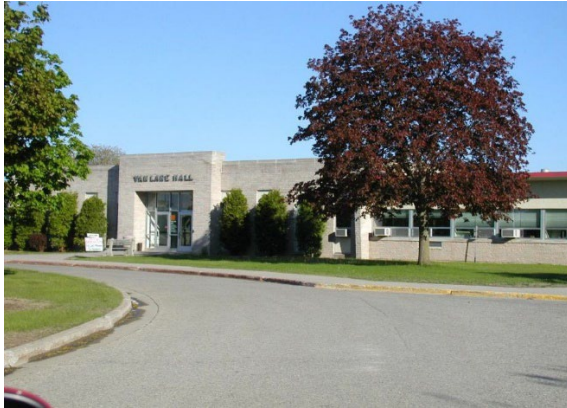
Facility: Van Lare Hall
Use Type(s): Classroom, Administration
Built: 1957
Area: 36,876 SF
Floors: 1 story

CRV:\$6,859,680
Priority Issues FCI:11.0%
0-5 Year FCI:26.1%
Priority Issues DMB:\$1,433,673
0-5 Year DMB:\$1,786,947
Priority Issues DMB Excess:\$1,090,689 over APPA 5% benchmark
0-5 Year DMB Excess:\$1,443,963 over APPA 5% benchmark
Priority Issues Maintain DMB:\$137,194 annual cost to maintain current DMB

- Building reroofed in 2008. (EPDM roof was at end of life, leaking and due for replacement)
- Surging of water levels in boilers periodically causes shut down due to low water.
- Unit ventilators in classrooms older, near end of expected lifespan.
- Poor ventilation, poor air circulation in offices.
- Several distribution panels at or near capacity.
- New 2x4 fluorescent fixtures in suspended ceilings installed in corridors in 2008.
- New suspended 2x4 lay-in in corridors, offices, 102 and computer labs.
- Exterior original full-lite aluminum frame doors at end of life. Original hardware failing and due for replacement
- Corridor and entry flooring removed and replaced (2009).
- VAT flooring in classrooms. Tile breaking apart and coming loose as adhesive fails.

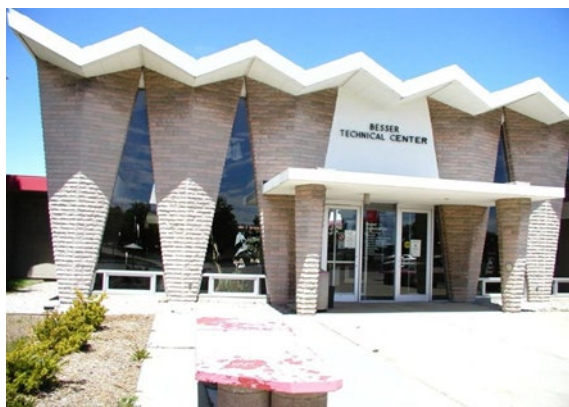
Besser Technical Center

Facility: Besser Technology Center
Use Type(s): Votech, Classroom, Kitchen/Food Service
Built: 1962
Area: 73,799 SF
Floors: 2 stories

CRV:\$15,092,750
Priority Issues FCI:1.2%
0-5 Year FCI:11.4%
Priority Issues DMB:\$182,622
0-5 Year DMB:\$1,722,083
Priority Issues DMB Excess:\$0 over APPA 5% benchmark
0-5 Year DMB Excess:\$967,445 over APPA 5% benchmark
Priority Issues Maintain DMB:\$301,855 annual cost to maintain current DMB

- HVAC Water pump bearing assembly failures becoming common with many replaced.
- Plumbing: Inadequate shut-off valves throughout building. Adding valves as repairs/modifications to the system are made.
- Power: Original underground 4160 V service, replaced in 2008 with 280/240v service.
- Casework: Science casework countertops in Physics lab at end of life, needs replacement or re-surfacing.
- Doors: (3) Machine shop and auto shop doors heavily rusted frames at end of life and due for replacement
- Floors: Some terrazzo deterioration at entries, due for re-grinding
- Site: Some cracking in concrete walks. Concrete at west entry heaved, chipped.
- Some washout at roof drain outlets

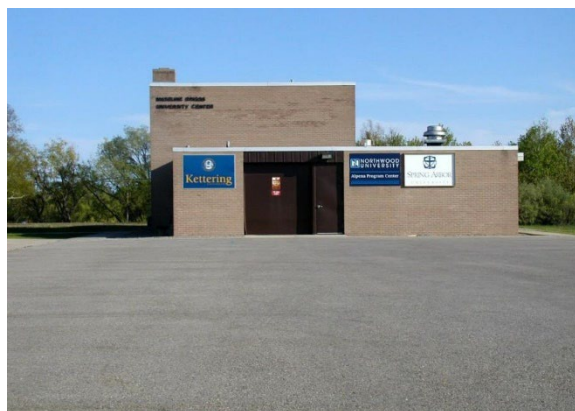
University Center

Facility: **University Center**
Use Type(s): Administration, Classroom
Built: 1969
Area: 3,220 SF
Floors: 1 story

CRV:\$592,480
 Priority Issues FCI:16.4%
 0-5 Year FCI:23.0%
 Priority Issues DMB:\$91,886
 0-5 Year DMB:\$128,584
 Priority Issues DMB Excess:\$67,543 over APPA 5% benchmark
 0-5 Year DMB Excess:\$106,350 over APPA 5% benchmark
 Priority Issues Maintain DMB:\$11,850 annual cost to maintain current DMB

- Durolast roof installed in 2008 (Built-up roof was at end of life, leaking and due for replacement)
- Extensive cracking in east block wall at garage
- Original single pane aluminum windows at end of life. Hopper windows with hardware in poor condition. Many units fastened shut.
- Heating controls poorly coordinated, temperature difficult to control
- Fire alarm original, not ADA compliant, not monitored.
- Exterior walks have settled at entry 3 +/-, trip hazard.

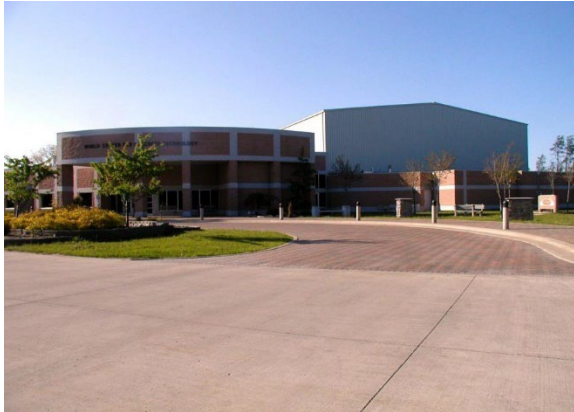
Facility: World Center for Concrete Technology

Use Type(s): Votech, Classroom, Lab

- Water infiltration at main lobby, especially at main window wall, flashing may be inadequate and weeps may not be working.
- HVAC: Bearing assembly failures on Bell & Gossett pumps
- AHU #2 (heat only) for labs 105 & 107, unit is cutting out on power overload; cause is unknown
- Power: Voltage fluctuates – usually over. Investigating supply problem with Alpena Power
- Past frequent breaker tripping problem solved by redistributing loads on panels for certain areas
- Doors: Roll-up doors – NE plant door gearbox leaks oil, SE plant door has minor forklift damage. Manual overhead door between 107 & 109 damaged by forklift and will not close
- Heaving problems at concrete pavers in front drives repaired in 2006
- Salt deterioration on bollard light fixtures at front, most lights replaced

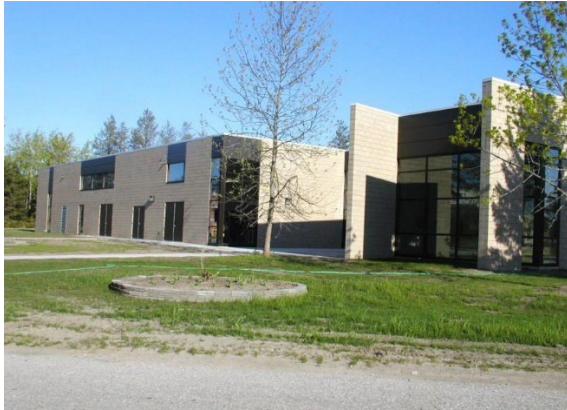
Facility: Fine Arts Center
Use Type(s): Votech, Classroom
Built: 2007
Area: 14,090 SF
Floors: 1 story

CRV:\$2,395,300
Priority Issues FCI:0.0%
0-5 Year FCI:1.0%
Priority Issues DMB:\$0
0-5 Year DMB:\$22,755
Priority Issues DMB Excess:\$0 over APPA 5% benchmark
0-5 Year DMB Excess:\$0 over APPA 5% benchmark
Priority Issues Maintain DMB:\$47,906 annual cost to maintain current DMB

- Building new, under warranty
- Building HVAC creates negative pressure problems and concerns about proper distribution and ventilation throughout labs.
- Revolving darkroom door – not ADA accessible (only door).
