**Alpena Community College  
Alpena, Michigan**

**Five-Year Capital Outlay Plan  
2025-2029  
Submitted October 2023**

#### **Condition Reports**

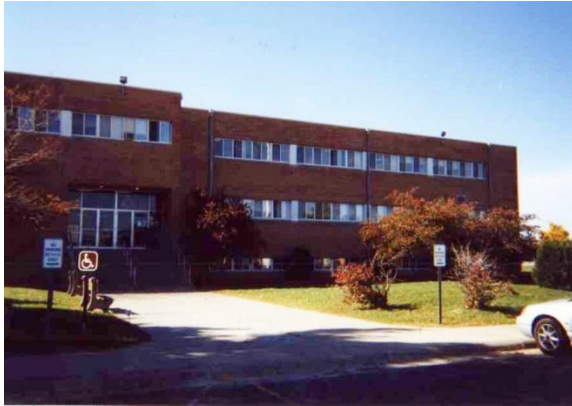
# Oscoda Campus

**Facility:** Oscoda Campus Building  
**Use Type(s):** Classroom, Administration  
**Built:** 1977  
**Area:** 31,140 SF  
**Floors:** 3 stories

CRV: .....\$5,854,320  
Priority Issues FCI: .....3.6%  
0-5 Year FCI: .....11.7%  
Priority Issues DMB: .....\$208,414  
0-5 Year DMB: .....\$685,541  
Priority Issues DMB Excess: .....\$0 over APPA 5% benchmark  
0-5 Year DMB Excess: .....\$392,825 over APPA 5% benchmark  
Priority Issues Maintain DMB: .....\$117,086 annual cost to maintain current DMB
