**Alpena Community College
Alpena, Michigan**

**Five-Year Capital Outlay Plan
2026-2030
Submitted October 2024**

Alpena Community College

Facility Condition Analysis

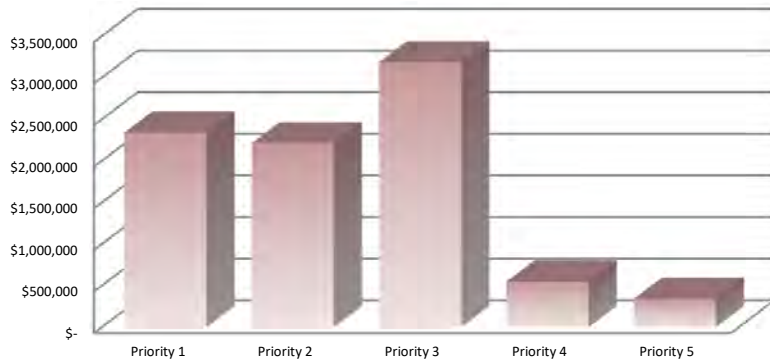
PROJECT COSTS BY PRIORITY

Priority 1	Priority 2	Priority 3	Priority 4	Priority 5	
A. STRUCTURE	\$ -	\$ 75,000	\$ -	\$ -	\$ -	\$ 75,000
B. SHELL	\$ 1,730,260	\$ 648,450	\$ 39,675	\$ -	\$ -	\$ 2,418,385
C. INTERIORS	\$ 20,300	\$ 568,380	\$ 152,500	\$ 167,020	\$ 342,630	\$ 1,250,830
D. SERVICES	\$ 585,500	\$ 801,665	\$ 1,198,715	\$ -	\$ -	\$ 2,585,880
E. EQUIPMENT AND FURNISHINGS	\$ -	\$ 94,300	\$ -	\$ -	\$ -	\$ 94,300
F. SPECIAL CONSTRUCTION AND DEMO	\$ -	\$ -	\$ -	\$ -	\$ -	\$ -
G. SITEWORK	\$ 3,900	\$ 26,250	\$ 1,795,150	\$ 382,700	\$ -	\$ 2,208,000
	\$ 2,339,960	\$ 2,214,045	\$ 3,186,040	\$ 549,720	\$ 342,630

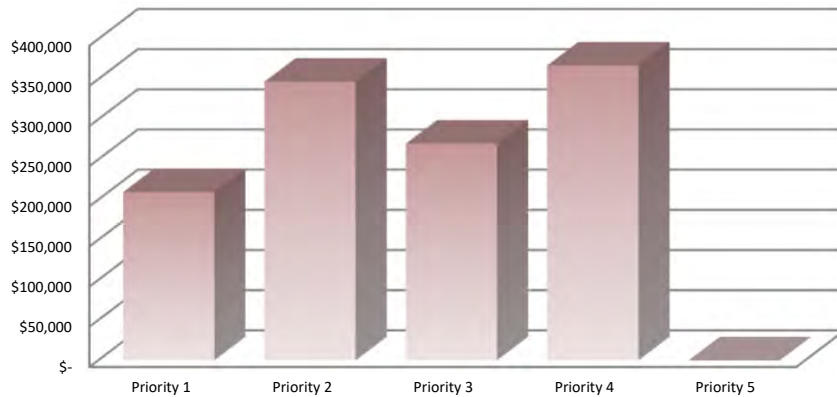
PROJECT COSTS BY PRIORITY

Priority 1	Priority 2	Priority 3	Priority 4	Priority 5	
A. STRUCTURE	\$ -	\$ -	\$ -	\$ -	\$ -	\$ -
B. SHELL	\$ 51,250	\$ -	\$ -	\$ 242,165	\$ -	\$ 293,415
C. INTERIORS	\$ 5,000	\$ 31,500	\$ 72,650	\$ -	\$ -	\$ 109,150
D. SERVICES	\$ 153,350	\$ 309,746	\$ 134,765	\$ 125,000	\$ -	\$ 722,861
E. EQUIPMENT AND FURNISHINGS	\$ -	\$ -	\$ -	\$ -	\$ -	\$ -
F. SPECIAL CONSTRUCTION AND DEMO	\$ -	\$ -	\$ -	\$ -	\$ -	\$ -
G. SITEWORK	\$ -	\$ 5,750	\$ 62,400	\$ -	\$ -	\$ 68,150
	\$ 209,600	\$ 346,996	\$ 269,815	\$ 367,165	\$ -

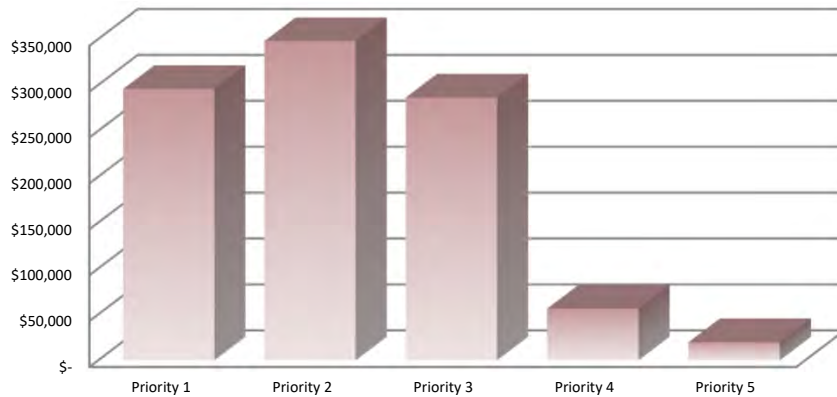
PROJECT COSTS BY PRIORITY

Priority 1	Priority 2	Priority 3	Priority 4	Priority 5	
A. STRUCTURE	\$ -	\$ -	\$ -	\$ -	\$ -	\$ -
B. SHELL	\$ 115,750	\$ 90,300	\$ 2,400	\$ -	\$ -	\$ 208,450
C. INTERIORS	\$ -	\$ 73,260	\$ 17,165	\$ 56,400	\$ 19,875	\$ 166,700
D. SERVICES	\$ 132,700	\$ 177,809	\$ 123,855	\$ -	\$ -	\$ 434,364
E. EQUIPMENT AND FURNISHINGS	\$ 4,320	\$ -	\$ -	\$ -	\$ -	\$ 4,320
F. SPECIAL CONSTRUCTION AND DEMO	\$ -	\$ -	\$ -	\$ -	\$ -	\$ -
G. SITEWORK	\$ 43,000	\$ 6,500	\$ 143,000	\$ -	\$ -	\$ 192,500
	\$ 295,770	\$ 347,869	\$ 286,420	\$ 56,400	\$ 19,875

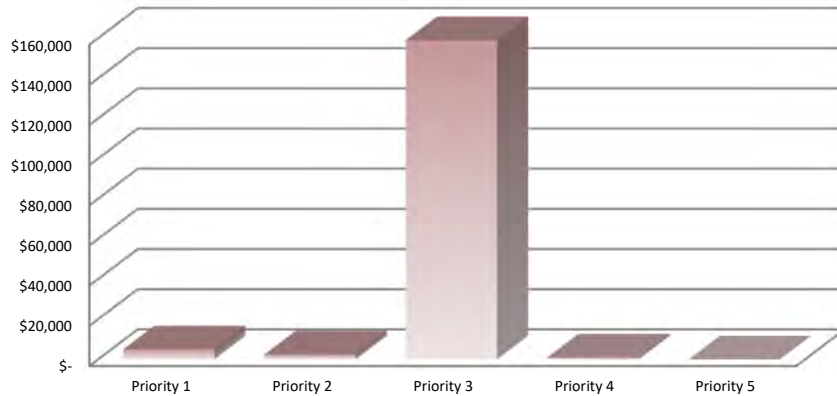
PROJECT COSTS BY PRIORITY

Priority 1	Priority 2	Priority 3	Priority 4	Priority 5	
A. STRUCTURE	\$ 5,000	\$ 1,000	\$ -	\$ -	\$ -	\$ 6,000
B. SHELL	\$ -	\$ -	\$ -	\$ -	\$ -	\$ -
C. INTERIORS	\$ -	\$ -	\$ -	\$ -	\$ -	\$ -
D. SERVICES	\$ -	\$ -	\$ -	\$ -	\$ -	\$ -
E. EQUIPMENT AND FURNISHINGS	\$ -	\$ -	\$ -	\$ -	\$ -	\$ -
F. SPECIAL CONSTRUCTION AND DEMO	\$ -	\$ -	\$ -	\$ -	\$ -	\$ -
G. SITEWORK	\$ -	\$ 1,500	\$ 159,000	\$ 1,000	\$ -	\$ 161,500
	\$ 5,000	\$ 2,500	\$ 159,000	\$ 1,000	\$ -
